The Space Shuttle Columbia Accident Investigation: Forensic Tools, Techniques, and Results

Steve McDanels

**Chief, Failure Analysis and Materials Evaluation Branch
NASA, Kennedy Space Center
steve.mcdanels@nasa.gov**

Columbia STS-107

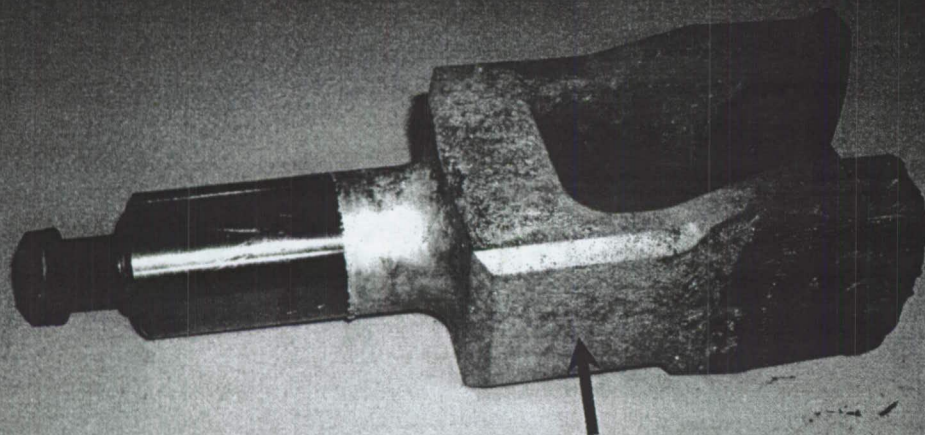
Main Landing Gear Uplock Roller

Heaviest splatter on
inboard side

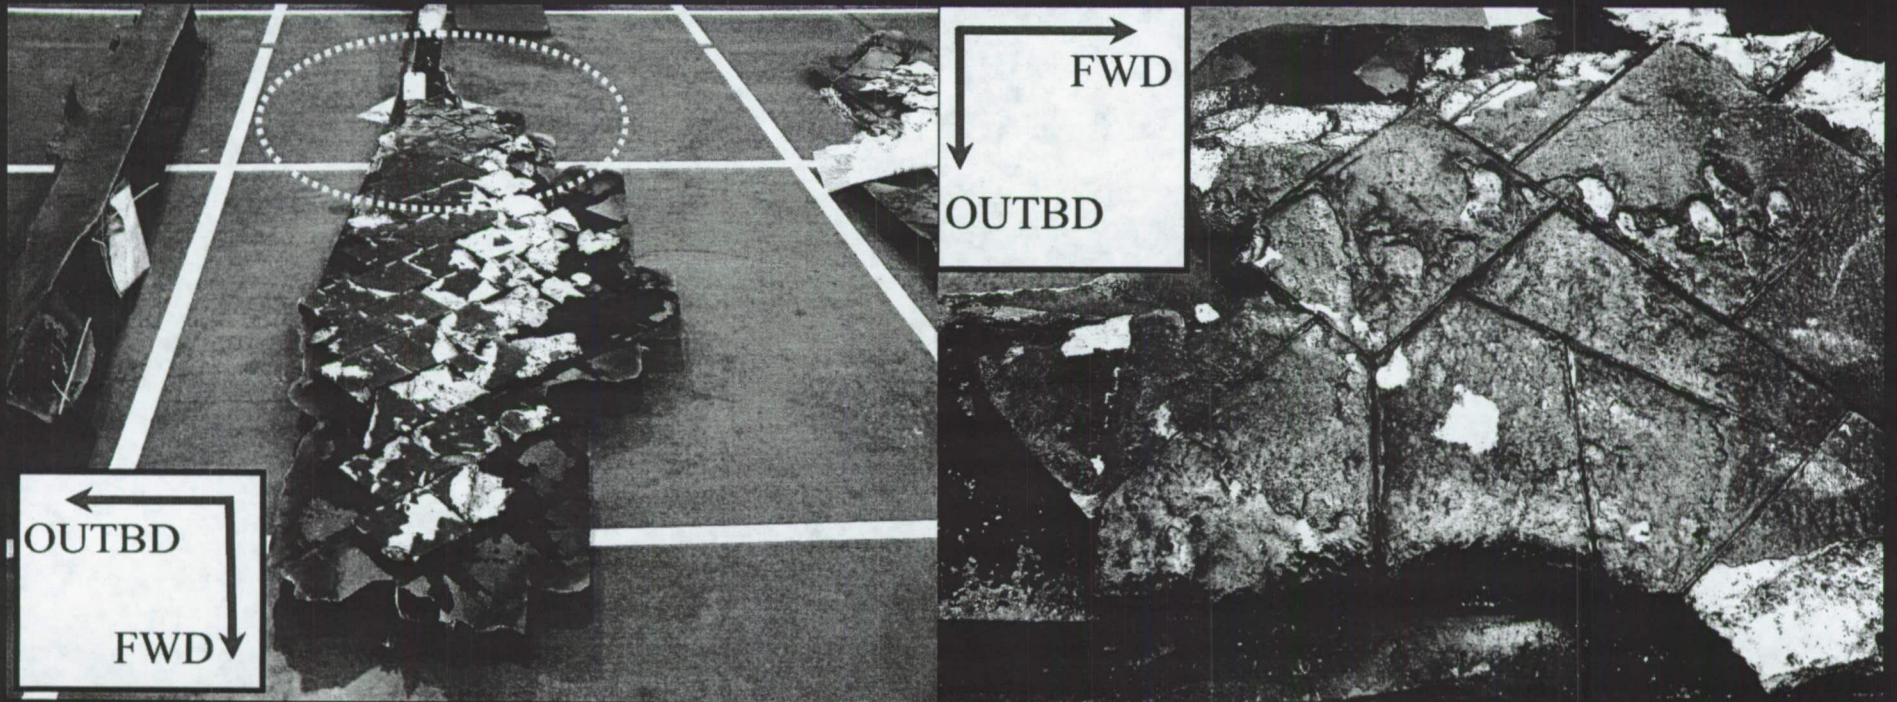
Midbody Panel- Erosion and tile
damage

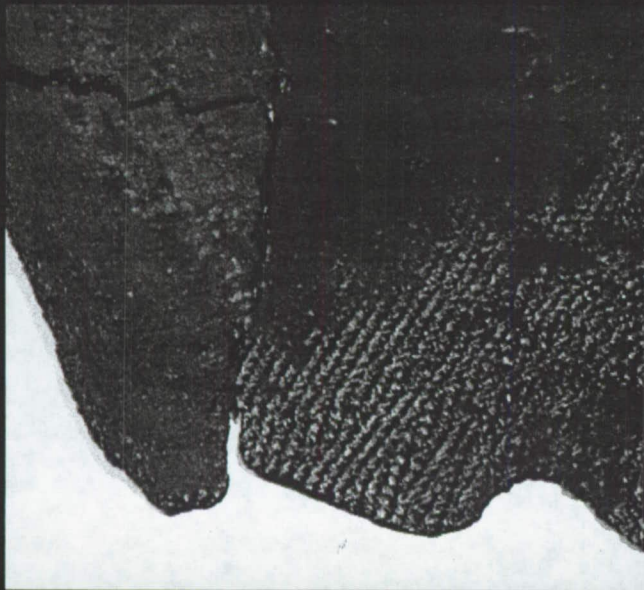
Mating LH RCC #8 Fragments

LH RCC #8 fragment (2 views)

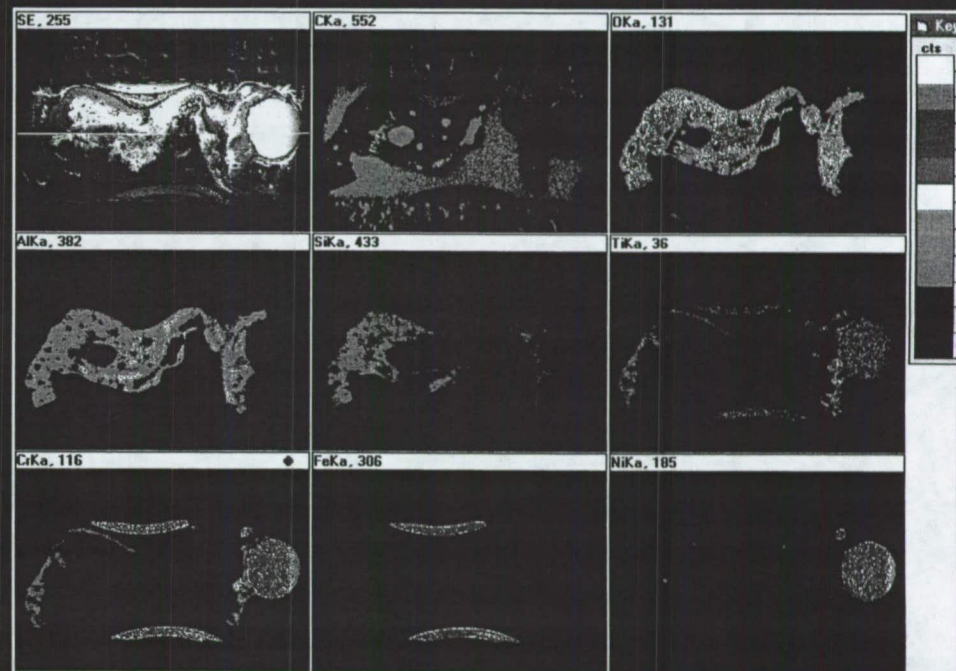
NASA KSC LABS DIVISION
 KSC-MSL-2003-0143-01
 RDS 18477-1 Slag Sample E2 Dot Map

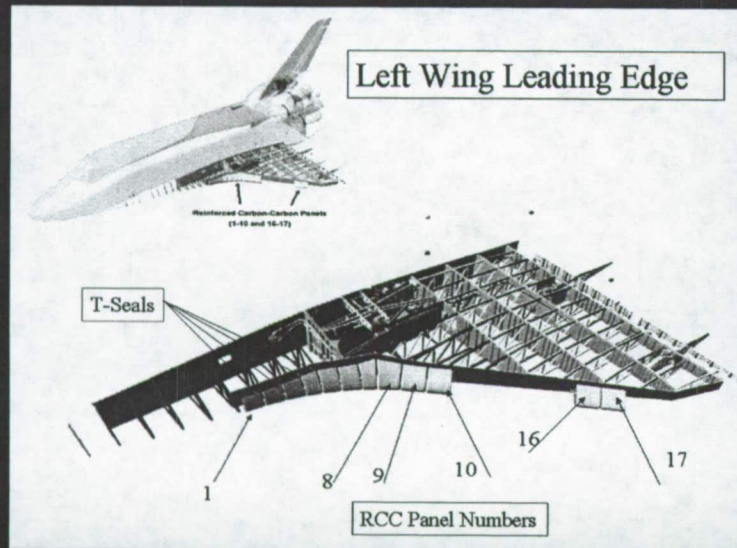
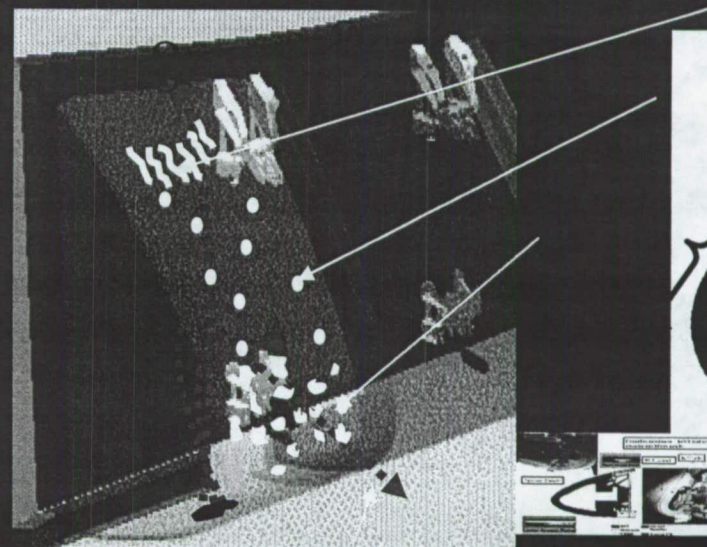
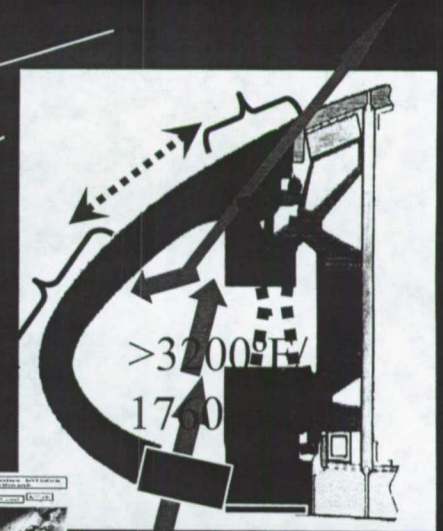
Failure Sequence

- Melting and vaporization of the Inconel 601 foil-covered cerachrome insulation blankets
- Slumping of the wing carrier panel tile immediately aft of the breach
- Erosion of the RCC adjacent to, and downstream of, the breach
- Melting and/or weakening of the Inconel 718 and A286 leading edge attach hardware
- Destruction of adjacent instrumentation and wire bundles
- Penetration of the aluminum wing leading edge spar
